Manhole Inspection Summary

Manhole # S43OO_002MH

Record Plat: **4300** Node: **002** Status: **Found**

Location Address: **Cliftview Ave**

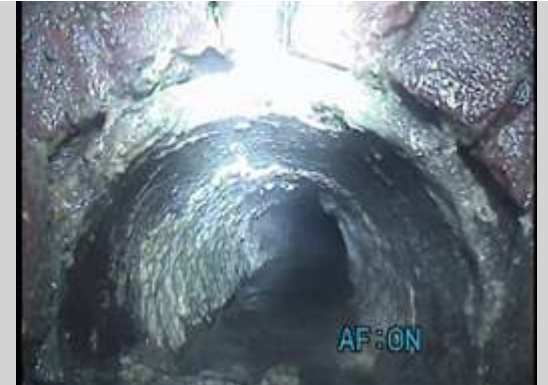
12 O'Clock Outflow

8 in. Circular Gravity Sewer
Pipe Out @ 12 O'Clock

Pipe Height: **8.4** (in.) Rod and Bar (Angled)
Pipe Material: **Clay** ☐ Pipe Lined
Invert Depth: **14.10** (ft.) Flow Characteristics: **Fast**
Deposits: ☒ None ☐ Mud ☐ Sludge ☐ Debris ☐ Grease
Silt Depth: (in.) Deposits Extent:
Infiltration: **None** Pipe Seal Cond: **Sound**

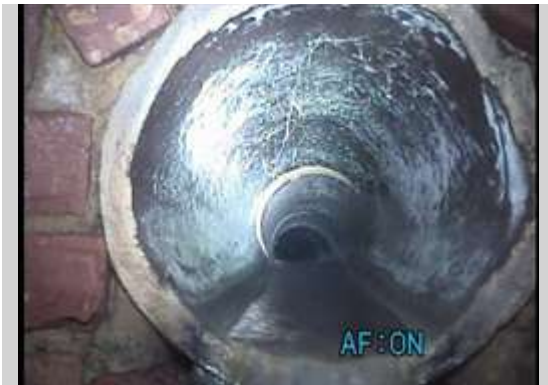
4 O'Clock Inflow

8 in. Circular Gravity Sewer
Pipe In @ 6 O'Clock

Pipe Height: **8.4** (in.) Rod and Bar (Angled)
Pipe Material: **Clay** ☐ Pipe Lined
Invert Depth: **8.60** (ft.) Flow Characteristics: **Fast**
Deposits: ☒ None ☐ Mud ☐ Sludge ☐ Debris ☐ Grease
Silt Depth: (in.) Deposits Extent:
Infiltration: **None** Pipe Seal Cond: **Sound**

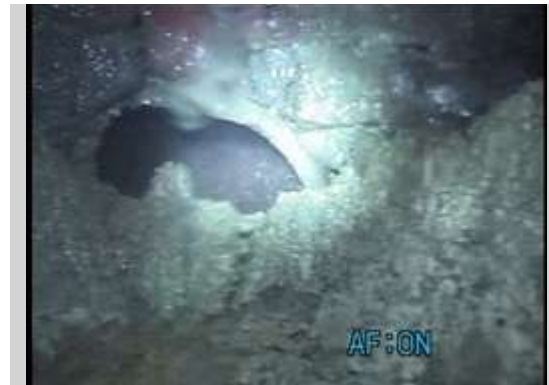
Drop In @ 6 O'Clock

Drop: **Outside** Rod and Bar
Angled: **Yes** Reading: **12.90** (ft.)
Inv Depth: **13.90** (ft.)
Drop Condition: **Open**

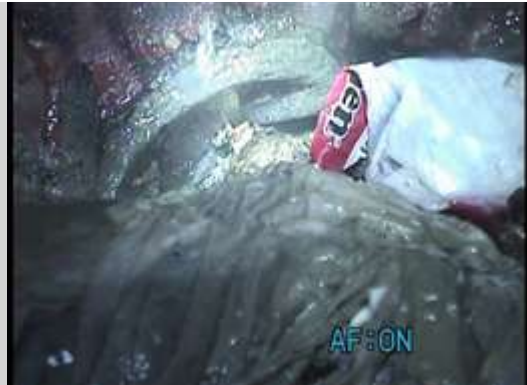
9 O'Clock Inflow

8 in. Circular Gravity Sewer

Pipe In @ 9 O'Clock

Pipe Height: **8.4** (in.) Rod and Bar (Angled)

Pipe Material: **Clay** ☐ Pipe Lined

Invert Depth: **13.85** (ft.) Flow Characteristics: **Fast**

Deposits: ☒ None ☐ Mud ☐ Sludge ☐ Debris ☐ Grease

Infiltration: **None** Pipe Seal Cond: **Sound**
